Port of Bellingham

Alternatives Report BLAINE MARINE DRIVE CONDITION SURVEY/ ASSESSMENT OF SHORELINE, BULKHEADS AND ROADWAY

Project Number 242015.011

November 24, 2015

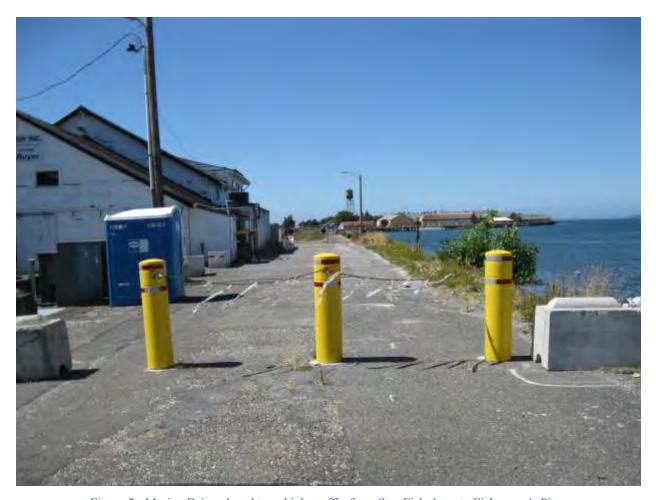
Marine Drive, between Star Fish, Inc., and Fisherman's Pier, has been closed to vehicle traffic since April 2014 but remains accessible to pedestrians and bicyclists. The closure was based on observations of pavement cracking and the presence of sink holes in the western 300 feet of Marine Drive as identified in a geotechnical Memorandum prepared by Geo Engineers in April 2014, see Figure 2.

Figure 2. Marine Drive closed to vehicle traffic from Star Fish, Inc., to Fisherman's Pier.

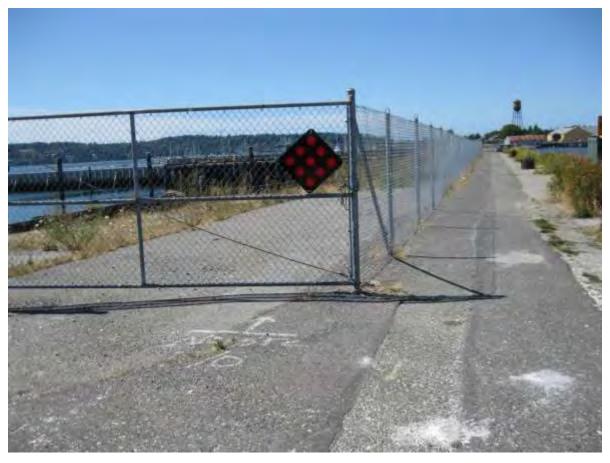
Per the geotechnical report, prepared by Landau Associates "Sinkholes and ground loss that extends several feet horizontally north of the bulkhead were observed behind the existing timber bulkhead. Pavement has been removed in this area and it appears that past filling activity had been attempted to bring the ground surface up to level for safety considerations; the area immediately behind the bulkhead wall is now fenced off to prevent pedestrian access." See Figure 3.

Figure 3. Marine Drive existing pavement reduced and fencing to prevent pedestrian access.

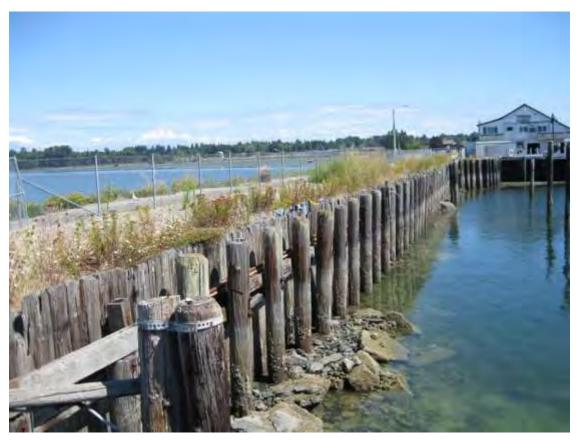
Based on visual inspection of the timber pile and lagging bulkhead at low tide, the timber bulkhead has reached the end of its useful life and is in need of replacement. The existing bulkhead consists of vertical timber piling, timber wales with a tieback rod system, and timber plank lagging. All timber members are in poor condition with loss of cross section and wood rot present. Many of the piling are split and have rotted from rainwater exposure on their tops. The steel tieback system is also in poor condition with corroded rods and hardware and missing nuts and washers.

Figure 4. Marine Drive existing timber bulkhead in poor condition.

The existing bulkhead is in poor condition and should be replaced for each of the options. Preliminary recommendations are to replace the existing bulkhead with a new sheet pile bulkhead driven in location as required at the edge of the roadway section for any of the alternatives or to replace the vertical bulkhead with a rip rap slope for options in Alternatives 3 and 4. The proposed new sheet pile wall would be made of solid steel interlocking sheets that would be driven well below the mudline. This wall would not have any openings and would prevent loss of material from the roadway while also providing support.
