# **HISTORIC AMERICAN BUILDINGS SURVEY DOCUMENTATION FOR THE CARPENTER BUILDING, PORT OF BELLINGHAM, 201 HARRIS AVENUE, BELLINGHAM, WA**

**September 2017**

**HISTORIC AMERICAN BUILDINGS SURVEY**  
**CARPENTER BUILDING**

**Historic Name:** Northwestern Shipbuilding Company Machine Shop

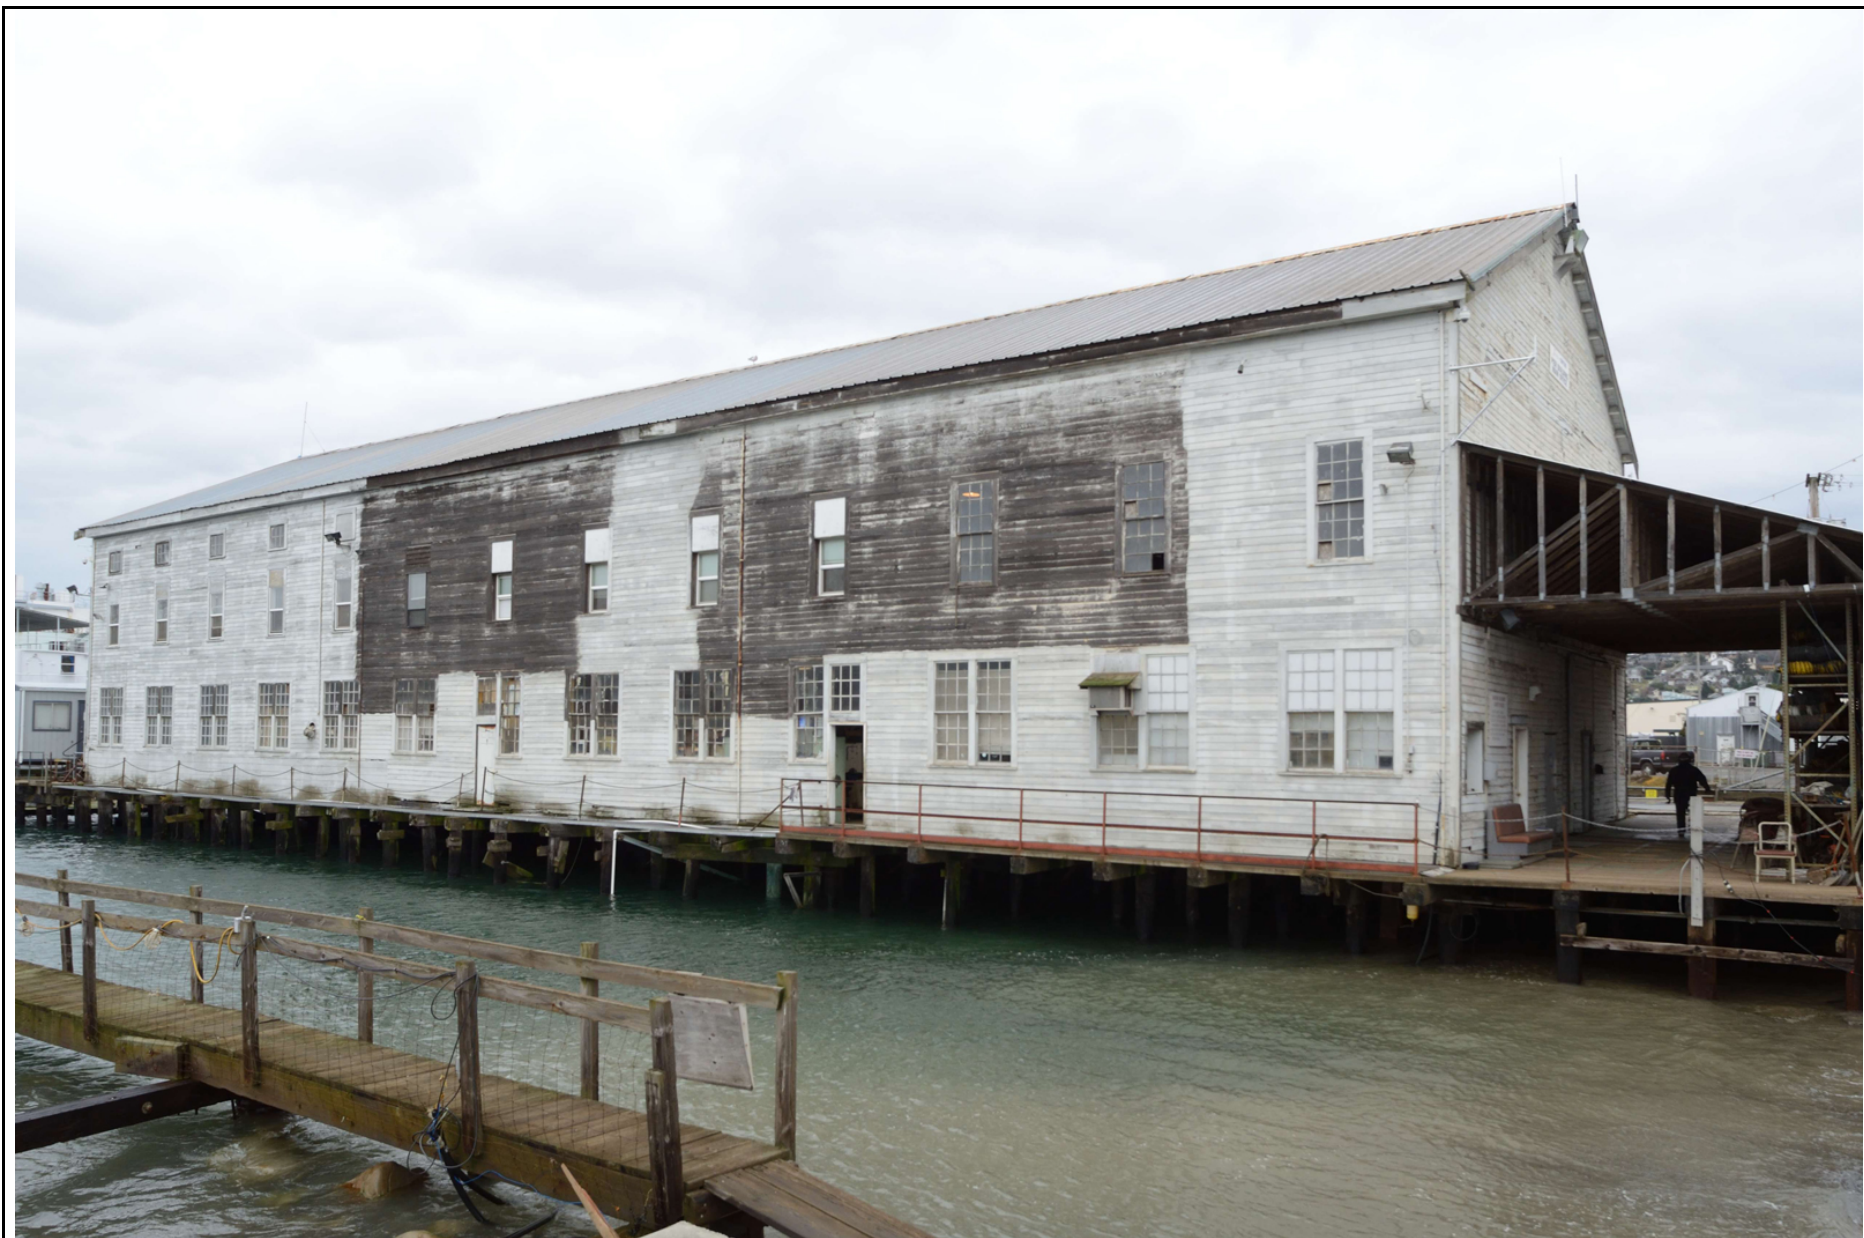
**Figure 3. Carpenter Building, View from Southwest—January 2015**  
ICF International, Seattle, WA

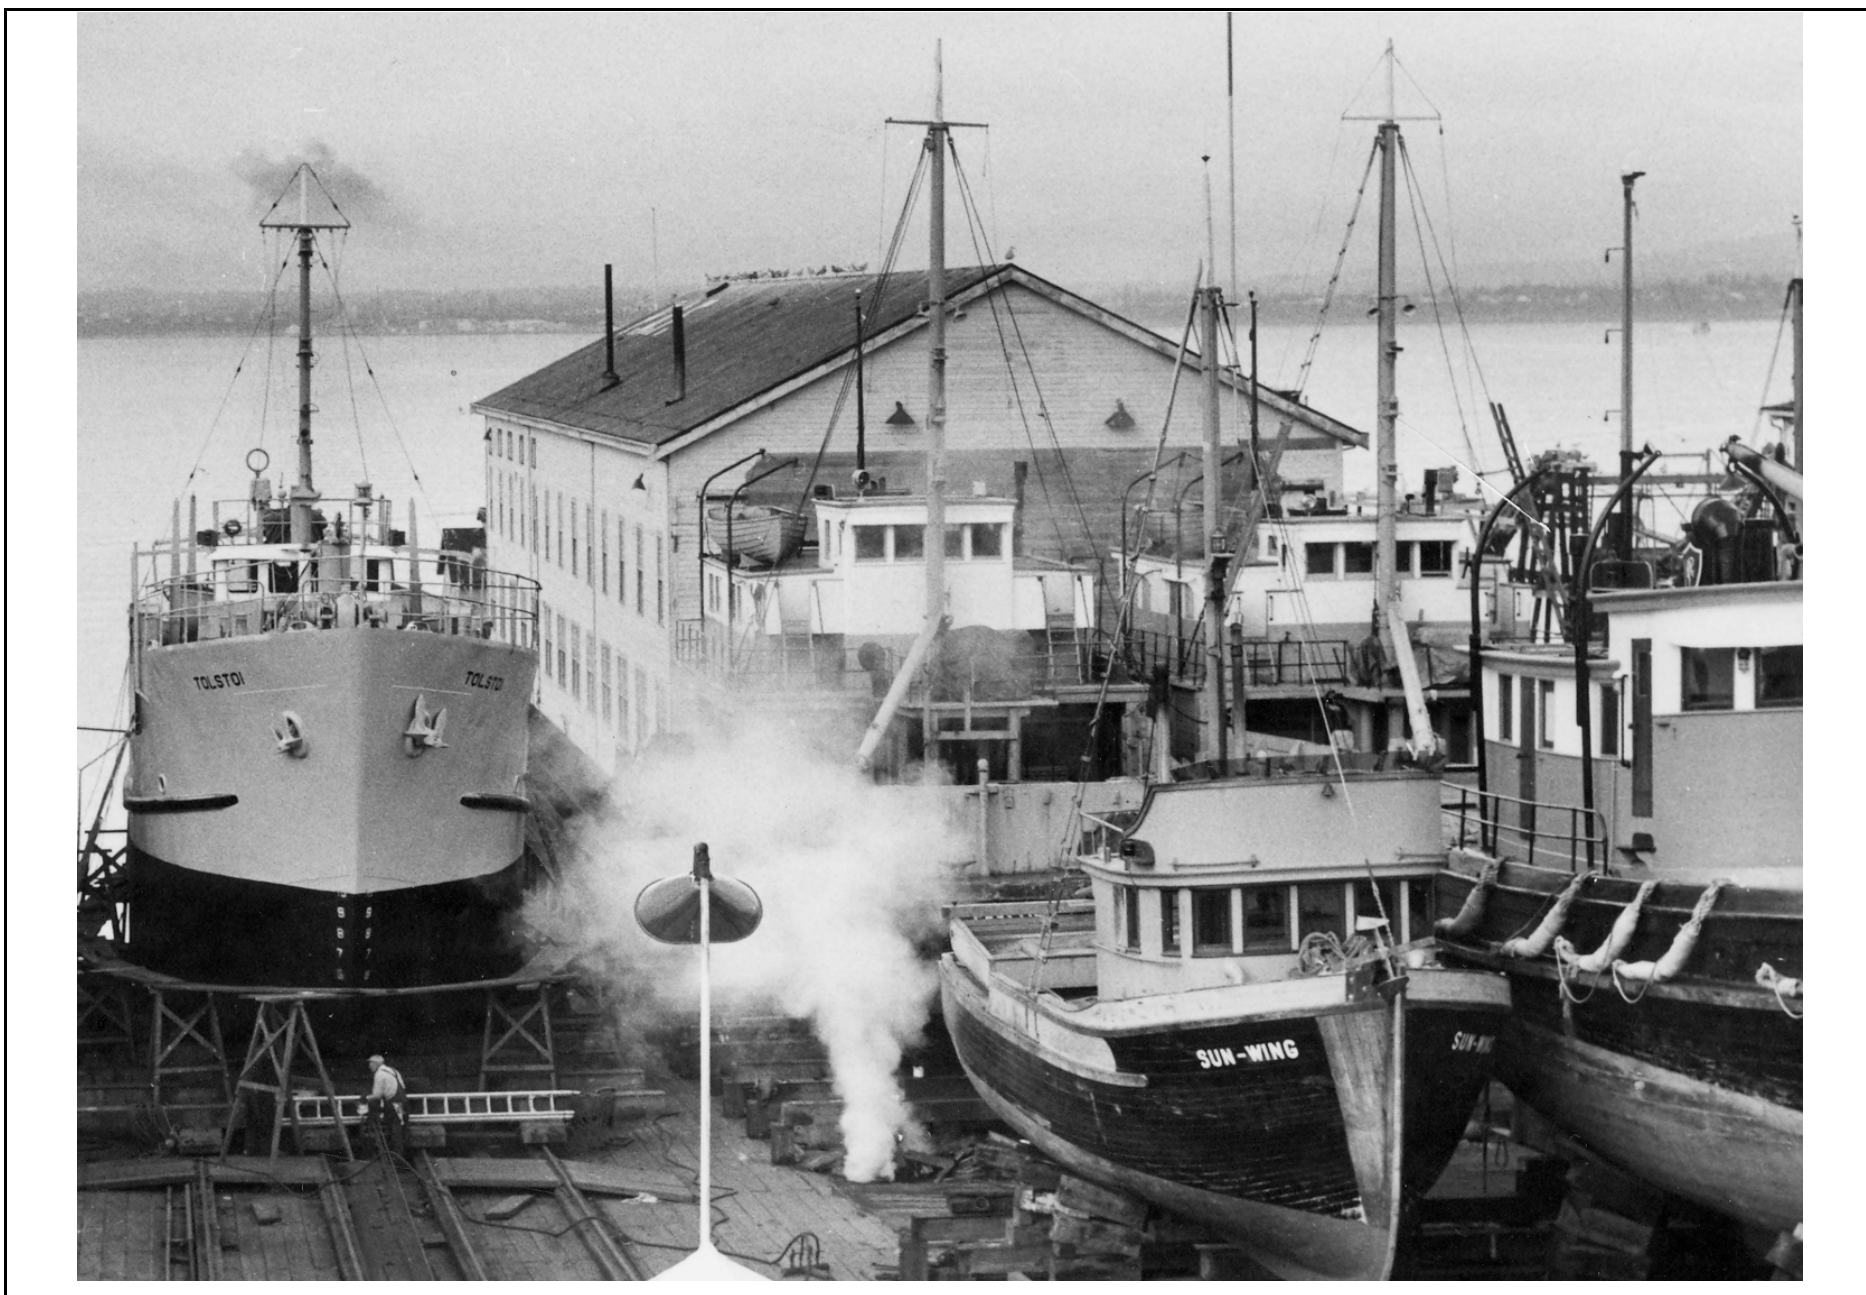
**Figure 5. Carpenter Building, View from the South—Circa 1955**  
Galen Biery Papers and Photographs #3333 (Partial View)  
Heritage Resources, Western Washington University, Bellingham WA, 98225-9123

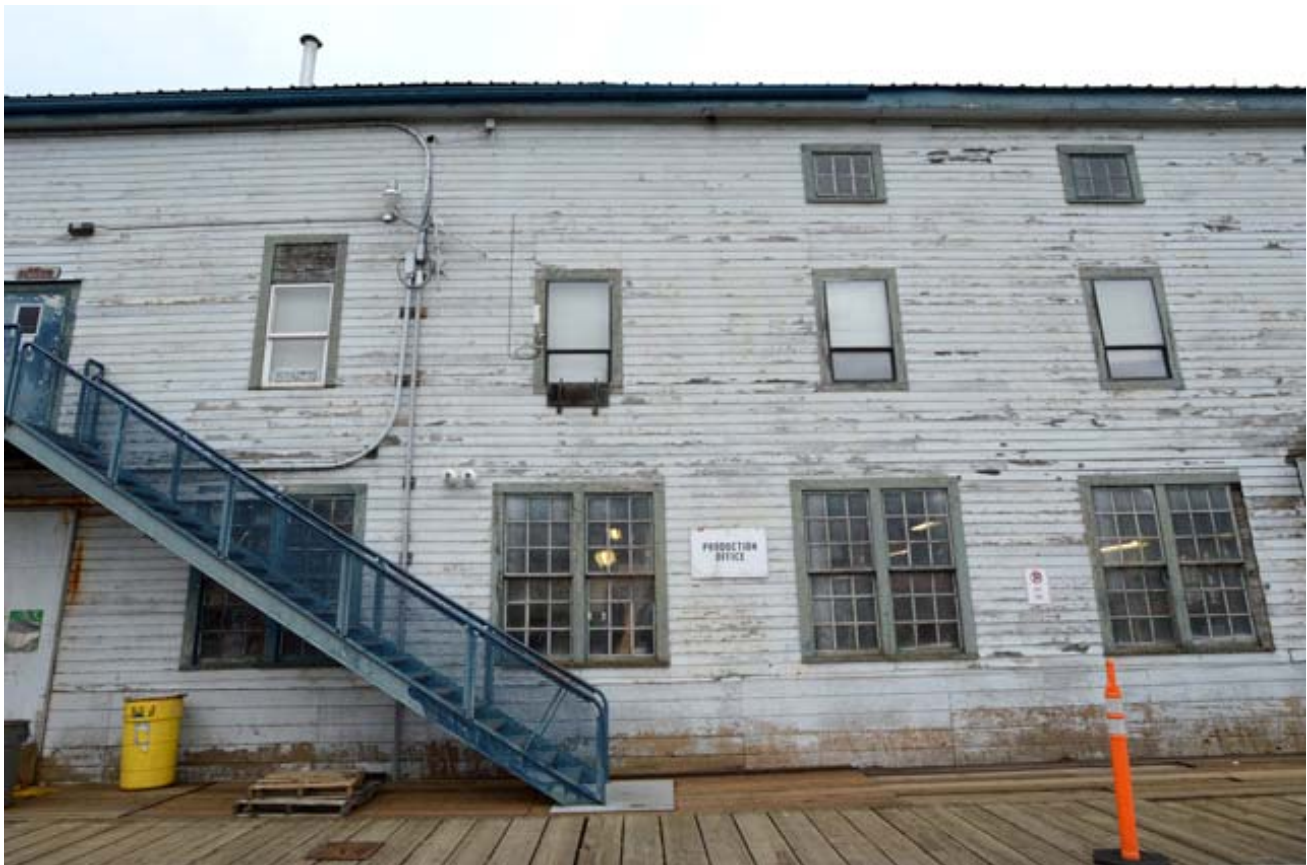
6. Detail of East Elevation, View West

Non-original door openings punctuate the east elevation's center bay on both the first and second stories in the place of former window openings. On the first story, the door opening consists of a large freight door opening with a side-sliding track door. The non-original door is formed of thick plywood panels suspended from a metal track by metal strap hinges. A small service window was cut into the door, which opens to the building's first floor supply room. On the second story, a former window in the center bay was removed and replaced by the existing personnel door opening. The door opening, which is shorter than the former window opening, has a wood frame with simple wood casings, and is fit with a non-original, metal door with a single light. It opens into a second floor exit hallway. The window opening was enclosed with matching exterior siding. One bay to the south of this doorway, another non-original door opening punctuates the elevation. It occupies the lower portion of an original, single window opening, which was enclosed with plywood. The door consists of a contemporary, pre-hung steel door and frame insert with a single light over recessed two-panel design. It opens into a second floor storage area. Both of these second-story doorways are accessed by a non-original metal staircase and landing that extends across the east elevation's center.

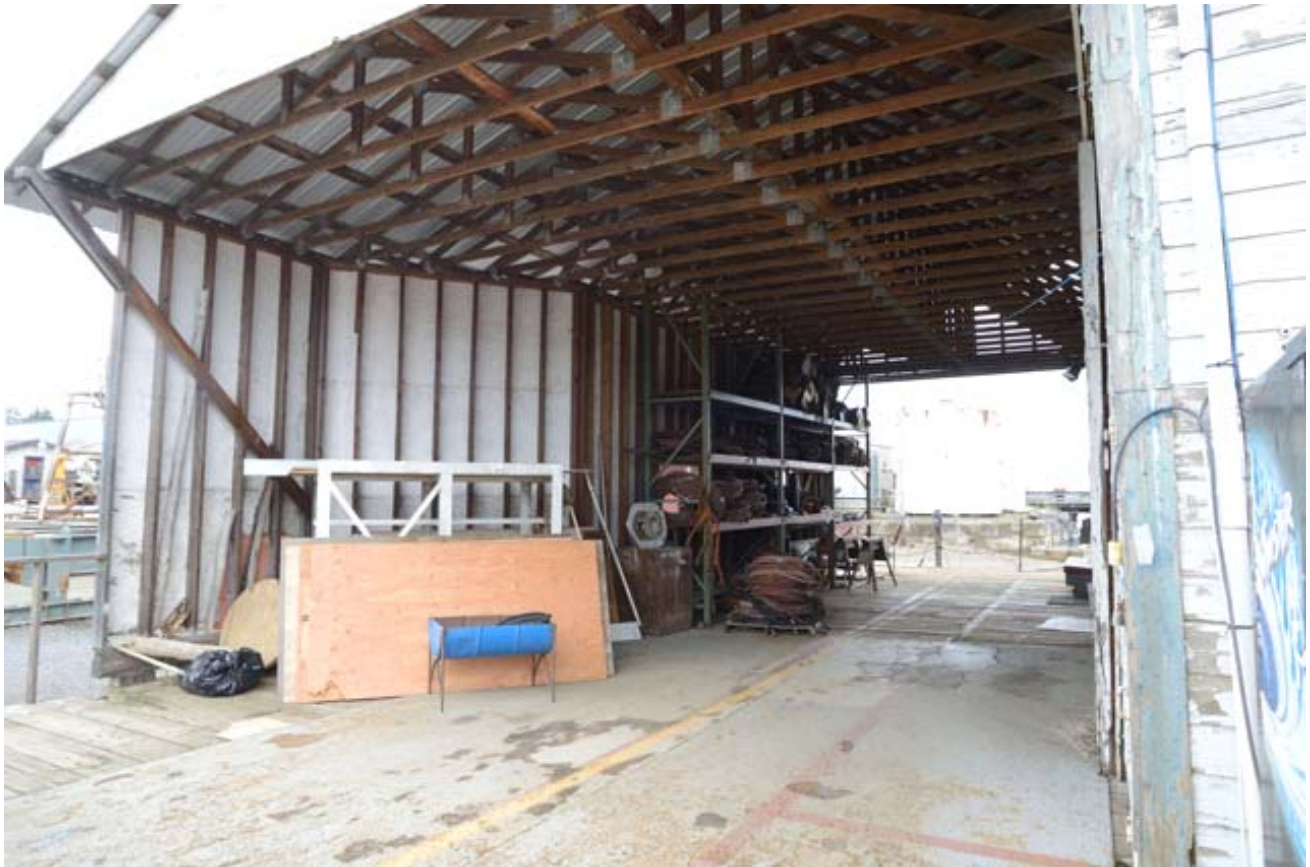
15. Detail of Vestibule Addition, View Southwest

The shed-roof vestibule that extends from the building's south elevation is a non-original addition, erected sometime after 1988. It consists of a large wood-frame truss that connects to the building's second story and is partially clad with plywood. It shelters several doorways and an exterior storage area at the building's south elevation.

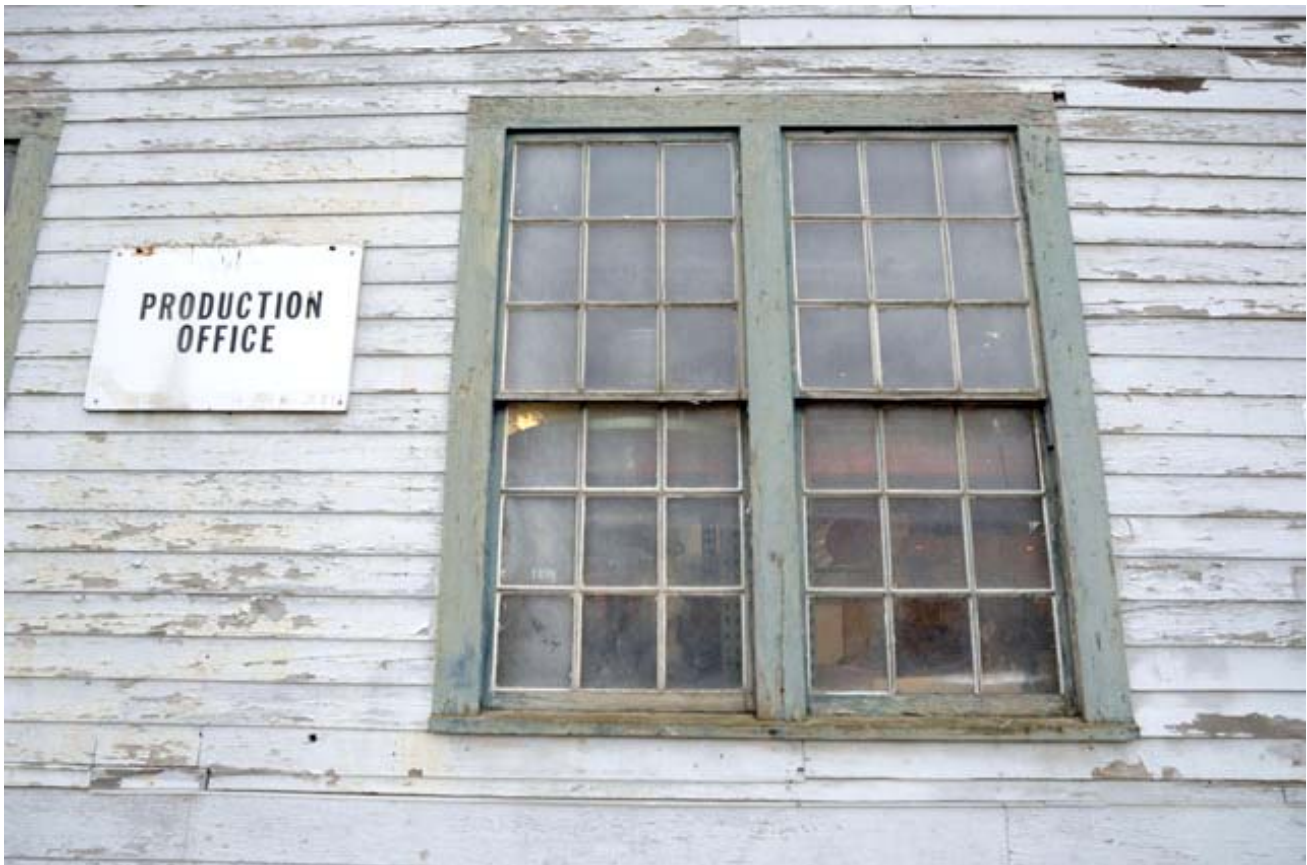
18. Detail of Window, East Elevation

The Carpenter Building's original fenestration primarily consisted of regularly-spaced pairs of window openings fit with nine-over-nine double-hung wood sashes on the first story, single windows fit with nine-over-nine double-hung wood sashes on the second story, and six-light wood sash casement windows at the building's third-story, all on its east and west elevations. Similarly configured windows punctuated the building's north elevation, flanking a large freight door opening and a pedestrian door on the first story, and an opening for a crane way on the second story. The aforementioned large, segmented arch opening characterized the building's south elevation. Other smaller pedestrian doorways punctuated the building's east and west elevations. All of the building's original window and door openings featured simple wood casings.
